FLOOD PLAIN INFORMATION, LEHIGH RIVER, JORDAN CREEK, TROUT CREE--ETC(U)

UNCLASSIFIED DAEN/NAP-82040/FPI01-71/0

4. TITLE (and Subtitle) Flood plain information, City of Allentown, Pennsylvania, Lehigh River, Jordan Creek, Trout Creek, City of Allentown, Pennsylvania	5. TYPE OF REPORT & PERIOD COVERED Flood Plain Information

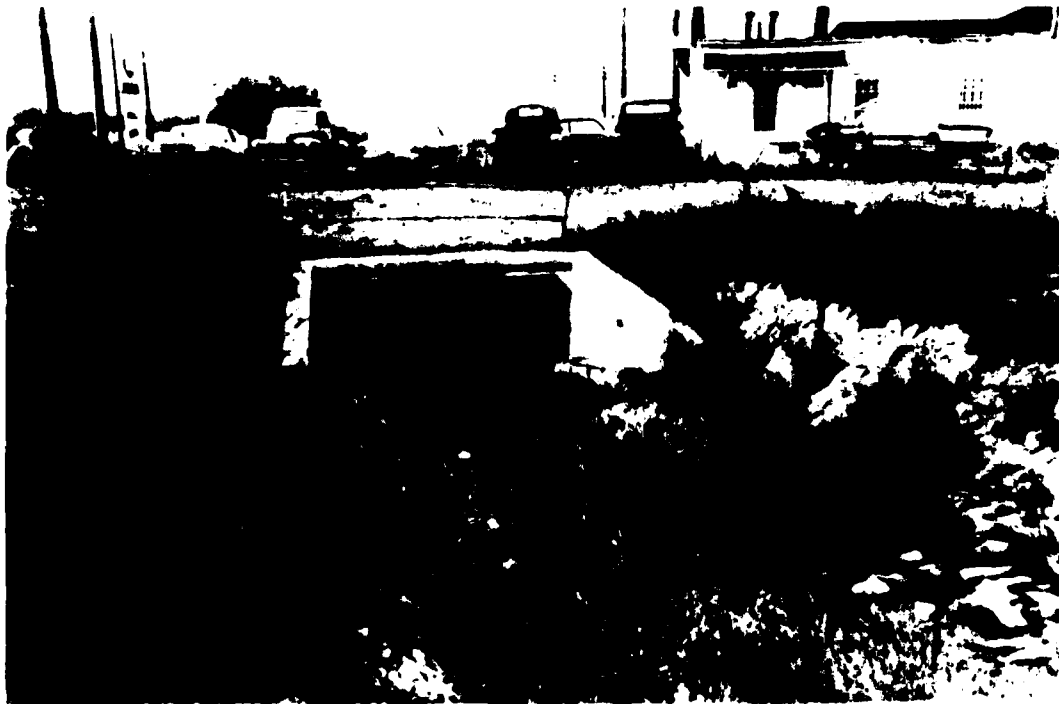
**FIGURE 4** - Vegetation obstructs the channel upstream of a box culvert across Trout Creek. Culvert is located in the vicinity of 4th and Brookdale Streets.

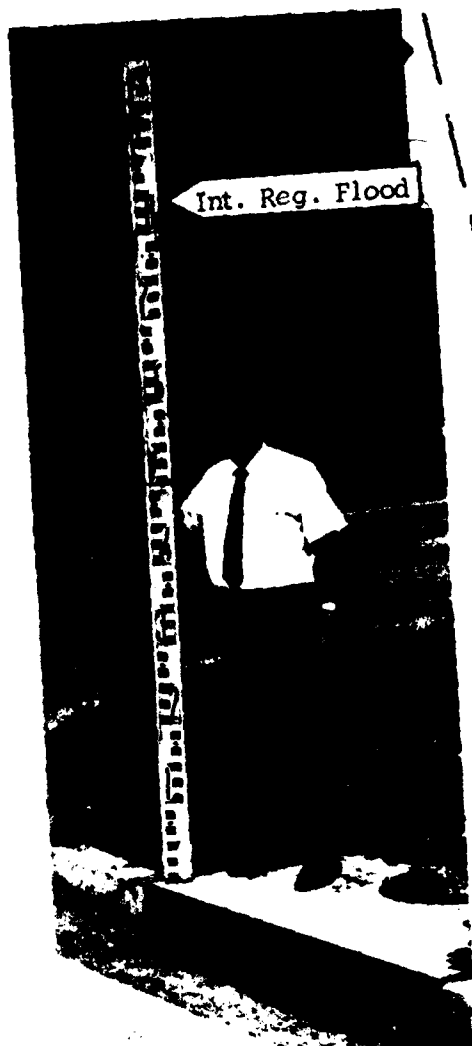
FIGURE 7 - Future flood height at  
3rd & Union Sts. Standard  
Project Flood would be  
8.8 feet above top of rod.

**Photographs, future flood heights** — The levels that the Intermediate Regional and Standard Project Floods are expected to reach at various locations in the City of Allentown are indicated on the following photographs.

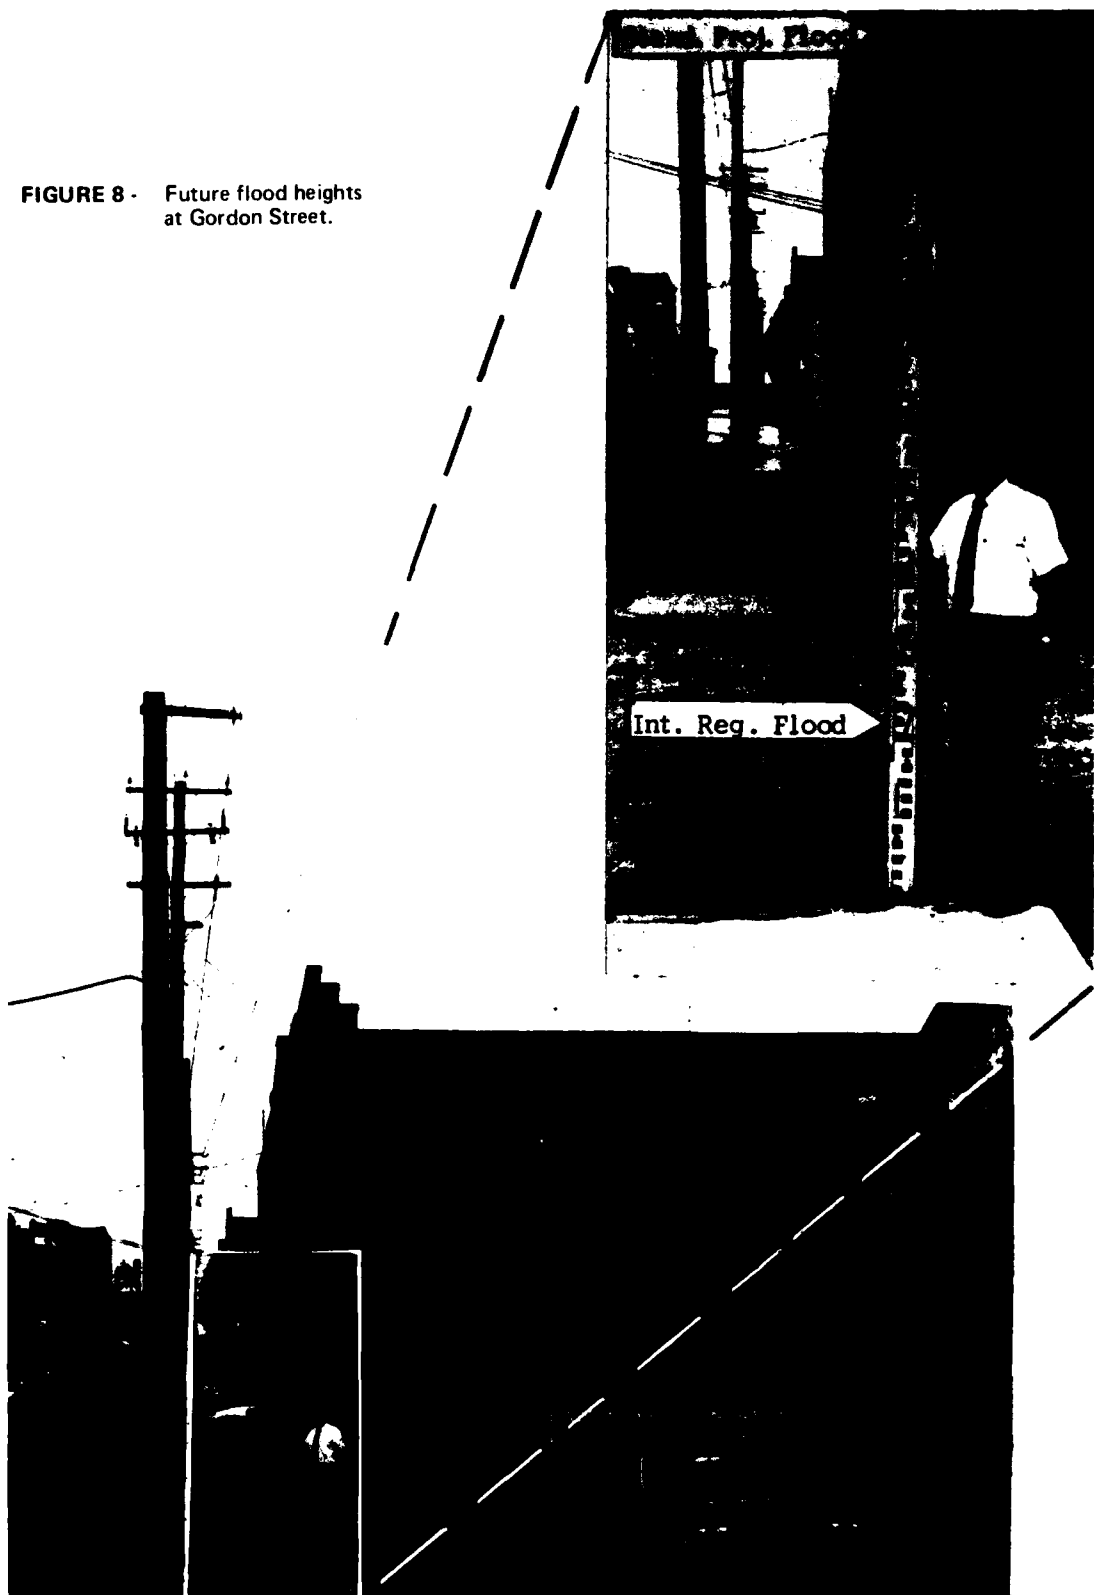
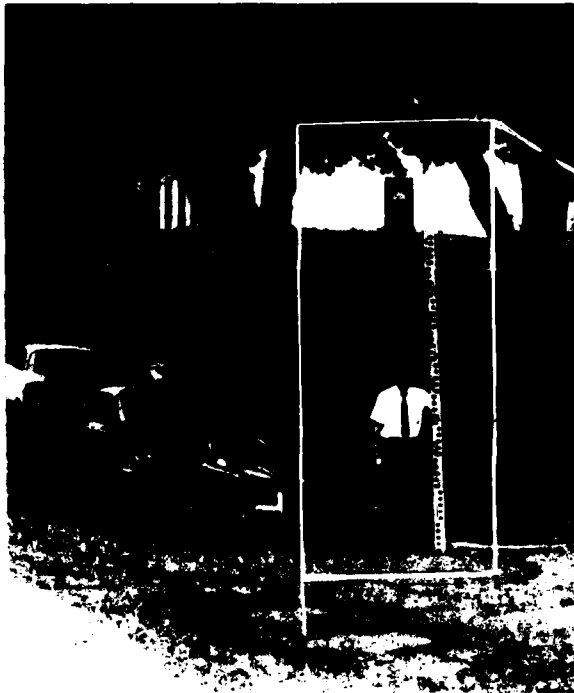
FIGURE 9 - Future flood heights at Auburn St. near the Hummel Warehouse. Standard Project Flood would be 1.8 feet above top of rod.

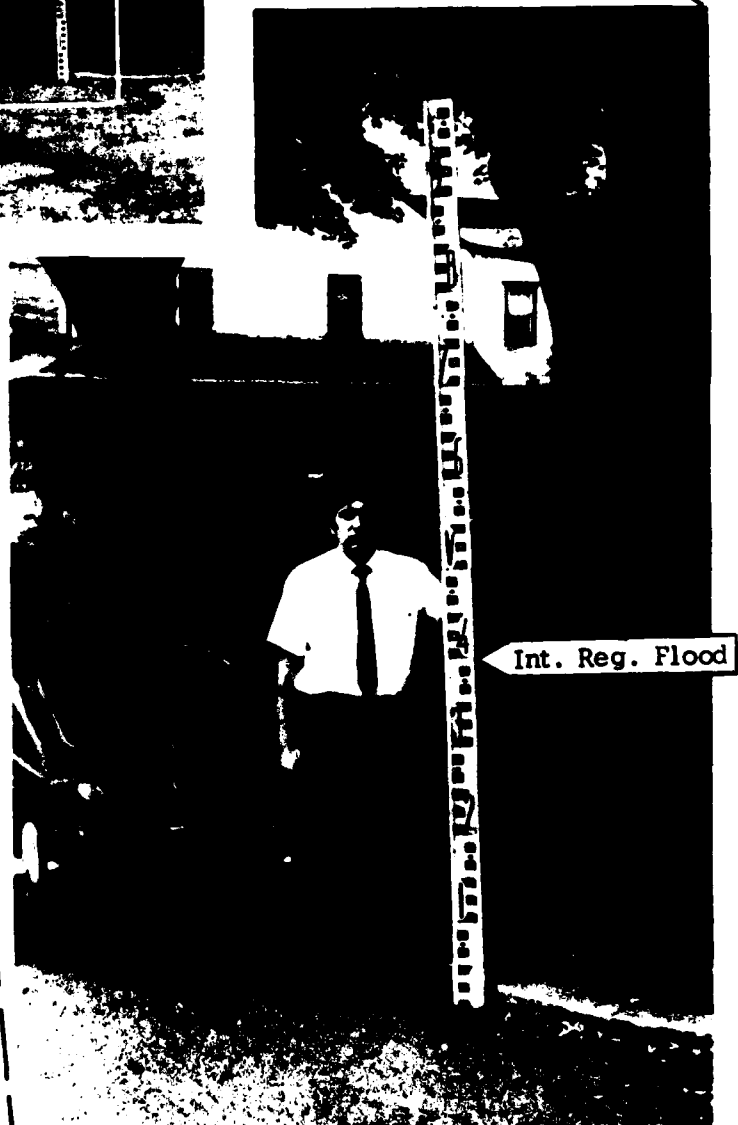
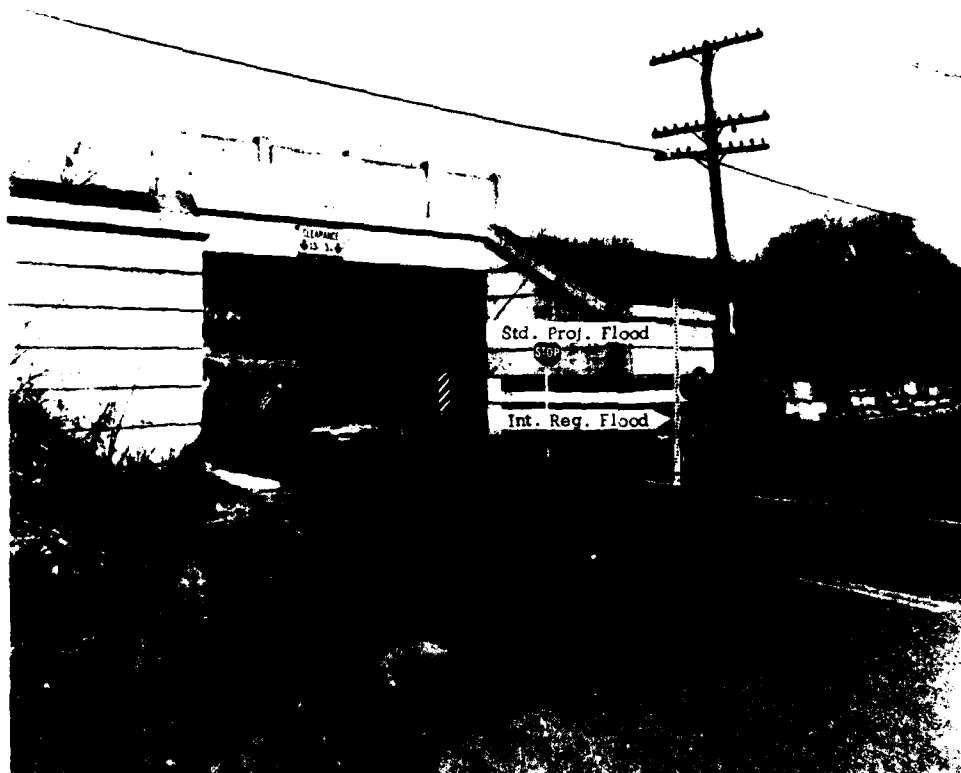
**FIGURE 10** - Future flood heights where Mack Boulevard passes under the Reading Railroad.
